River Misbourne Appraisal

December 2023

The aim of the River Misbourne Appraisal is to appraise the river health, set out the key challenges on the river and provide a tool kit of measures that can be used to address these challenges.

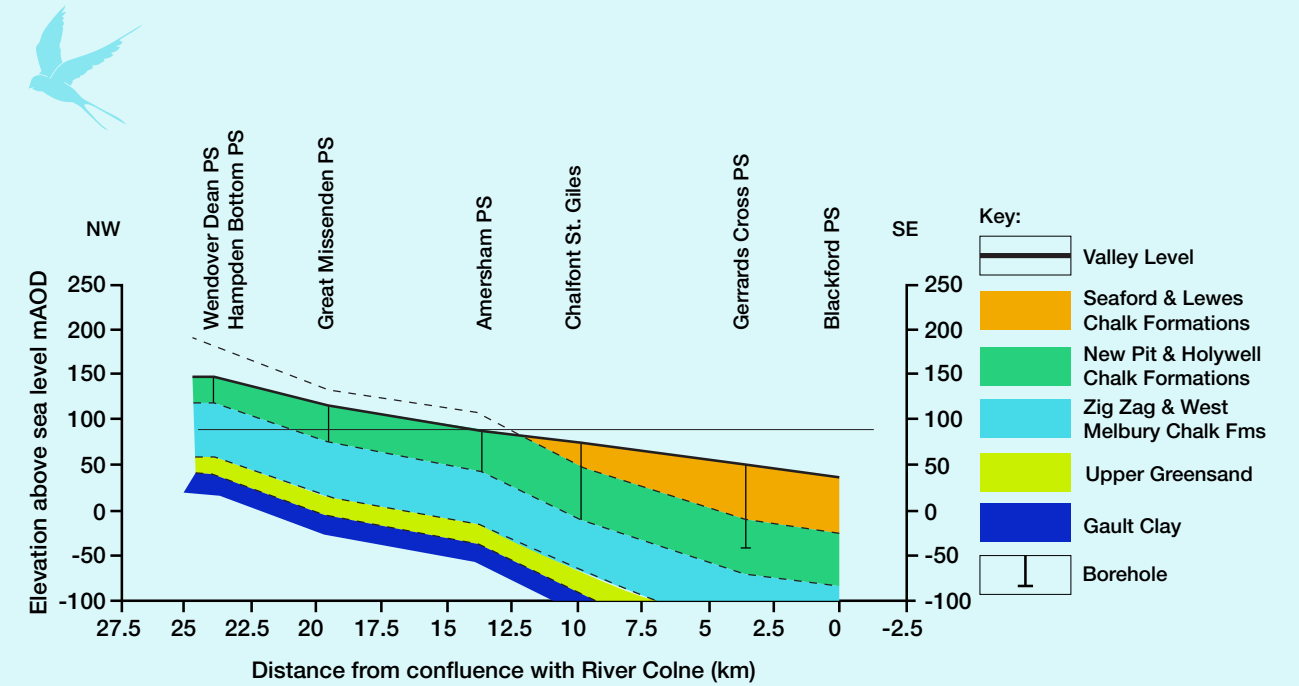
Geological section along the Misbourne valley showing the different geological formations.

The chalk bedrock comprises different layers or formations with different permeability characteristics. Where these intersect the valley surface, they can have a significant effect on the flow in the river and therefore whether the river is ephemeral or perennial. In addition, the bedrock between Amersham and Chalfont St. Peter has been heavily eroded and disaggregated by the proto-Thames which flowed across the valley circa 450,000 years ago (Bailey, 2008). Due to these geological variations, the river can be divided into four reaches as shown below.

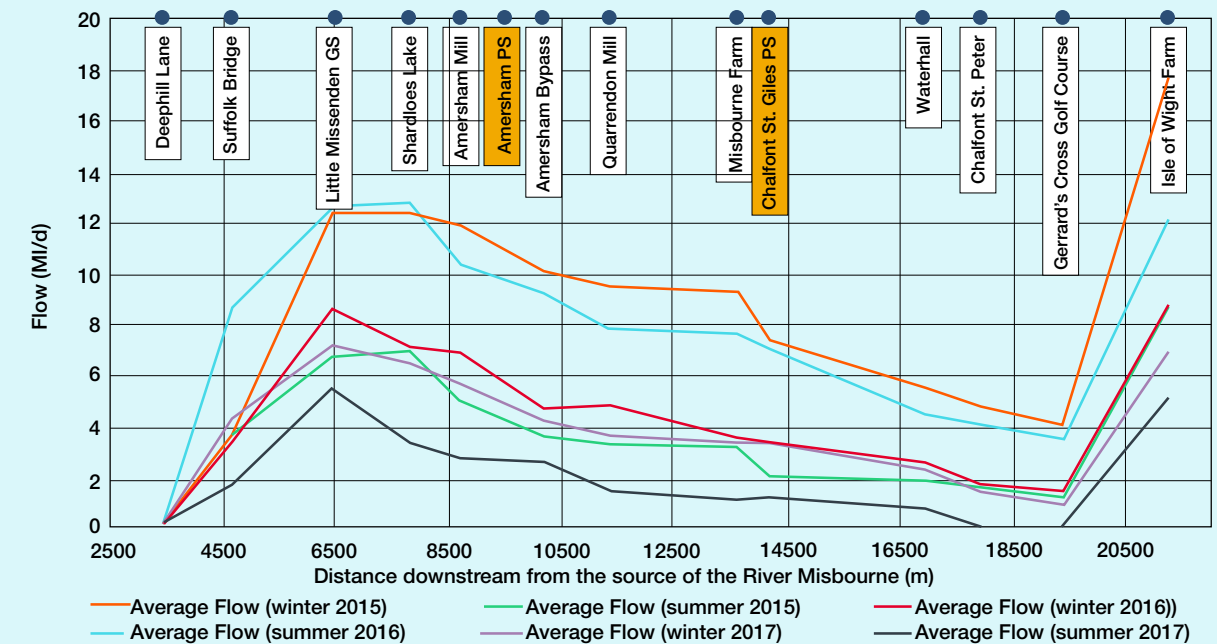
Note: The winter half-year (October 2016–March 2017) was particularly dry in southern England with below average rainfall which continued to affect groundwater levels during the summer 2017 despite persistent and heavy rainfall. Groundwater levels continued to decline until November 2017 resulting in notably low groundwater levels (Turner et al. 2021).

Flow in the river along the Misbourne valley as monitored during 2015-2017 showing flows increasing and decreasing.

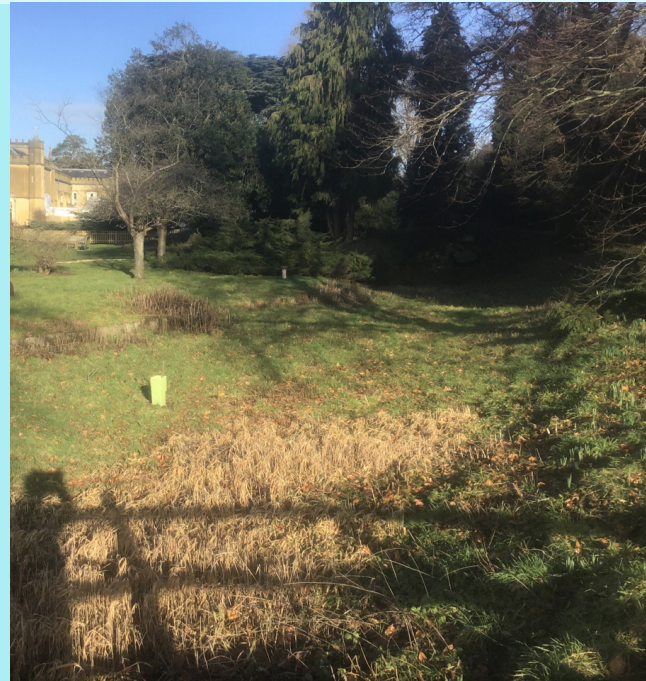
Great Missenden to Little Missenden

- **Impounding structures** - artificial ponds and lakes within the reach.
- **Over-deep and over-wide** – modified channel cross-section, including past dredging.
- **Straightened planform**
- **Culverting** - through Buryfield Recreation Ground
- **Overshading** – in some sections.
- **Lack of shade**- no refuge/resilience to high temperatures.
- **Lack of riparian habitat**- no natural floodplain habitat to support in channel species foraging, breeding and migrating opportunities.
- **Disconnected floodplain** – in some sections.

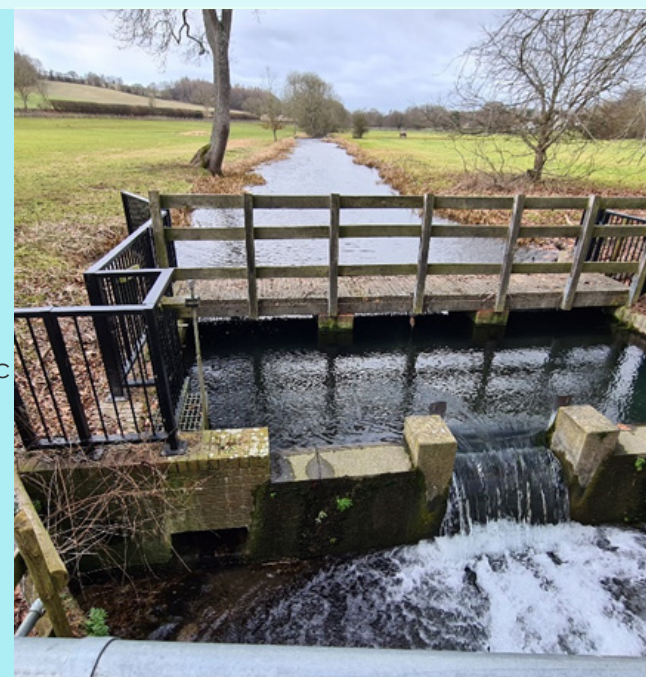
Little Missenden to Amersham

- **Impounding structures** – holding back water to form Shardeloes Lake, and ponding smaller sections upstream.
- **Weirs and sluices** – throughout reach.
- **Bank modification** – embankments, bank protection, re-profiled banks.
- **Over-deep and over-wide** - modified channel cross-section, including past dredging.
- **Channel realignment** – modifications from historic milling, including straightening.
- **Lack of shade**- no refuge/resilience to high temperatures.
- **Lack of riparian habitat**- no natural floodplain habitat to support in channel species foraging, breeding and migrating opportunities.
- **Disconnected floodplain**
- **Invasive species**

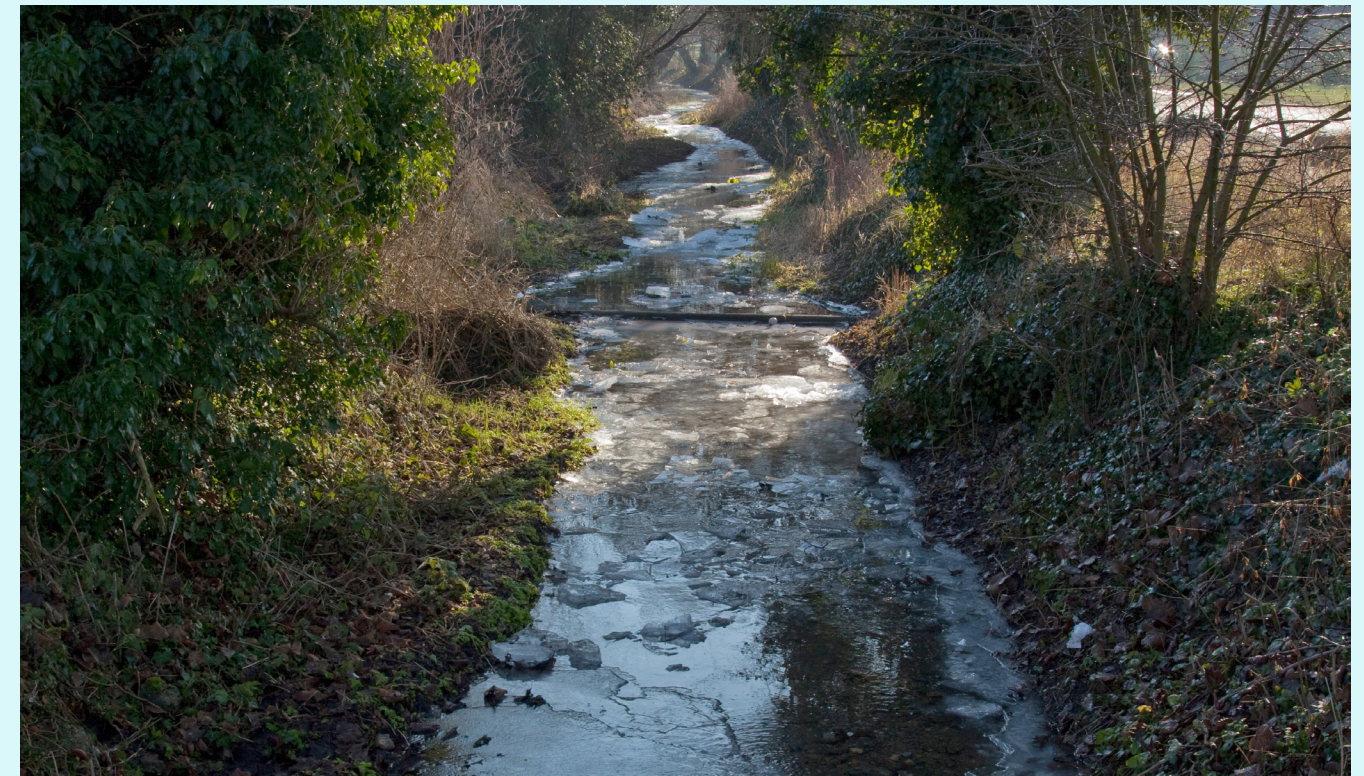
Straightened, over deep channel with steep banks. The channel is disconnected from the floodplain.

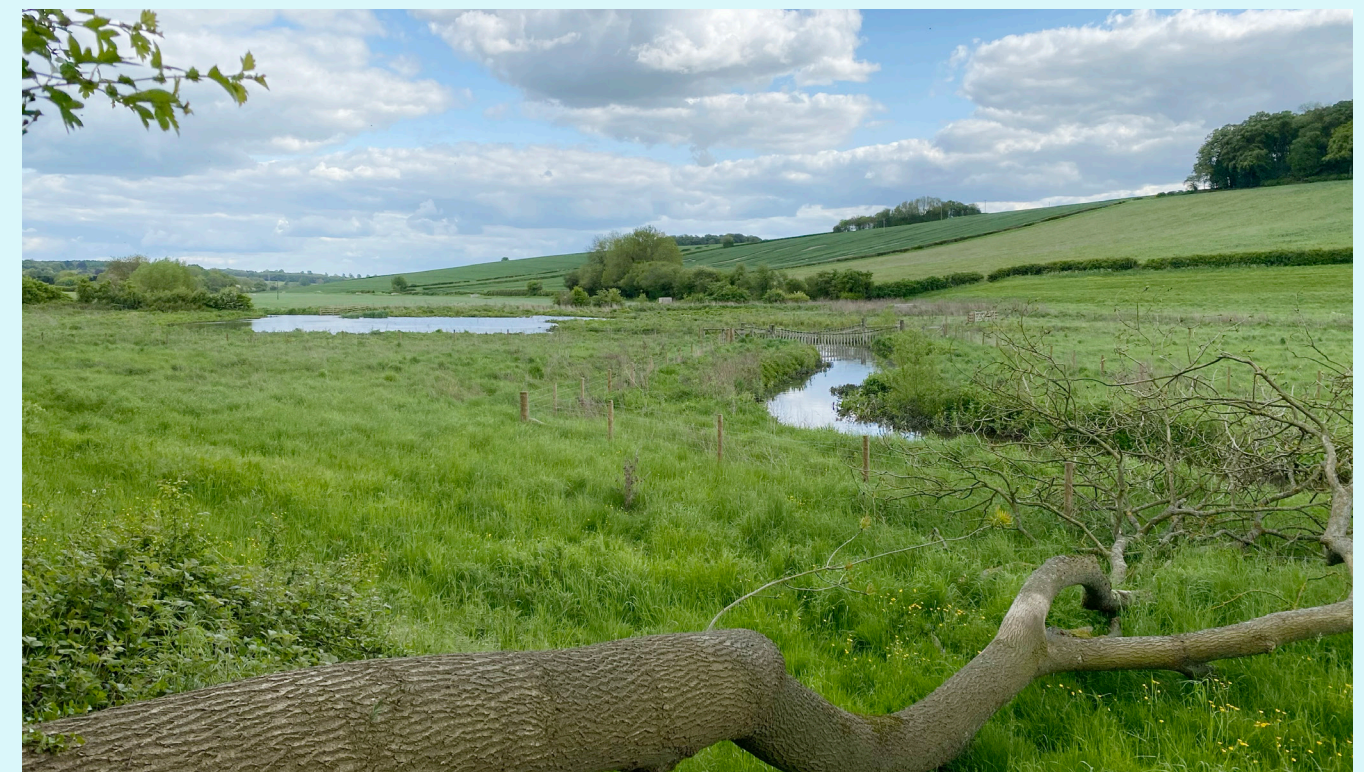
Restoration work near Quarrendon Mill. The channel has been restored back to the valley bottom. Note wide channel and shallow banks.

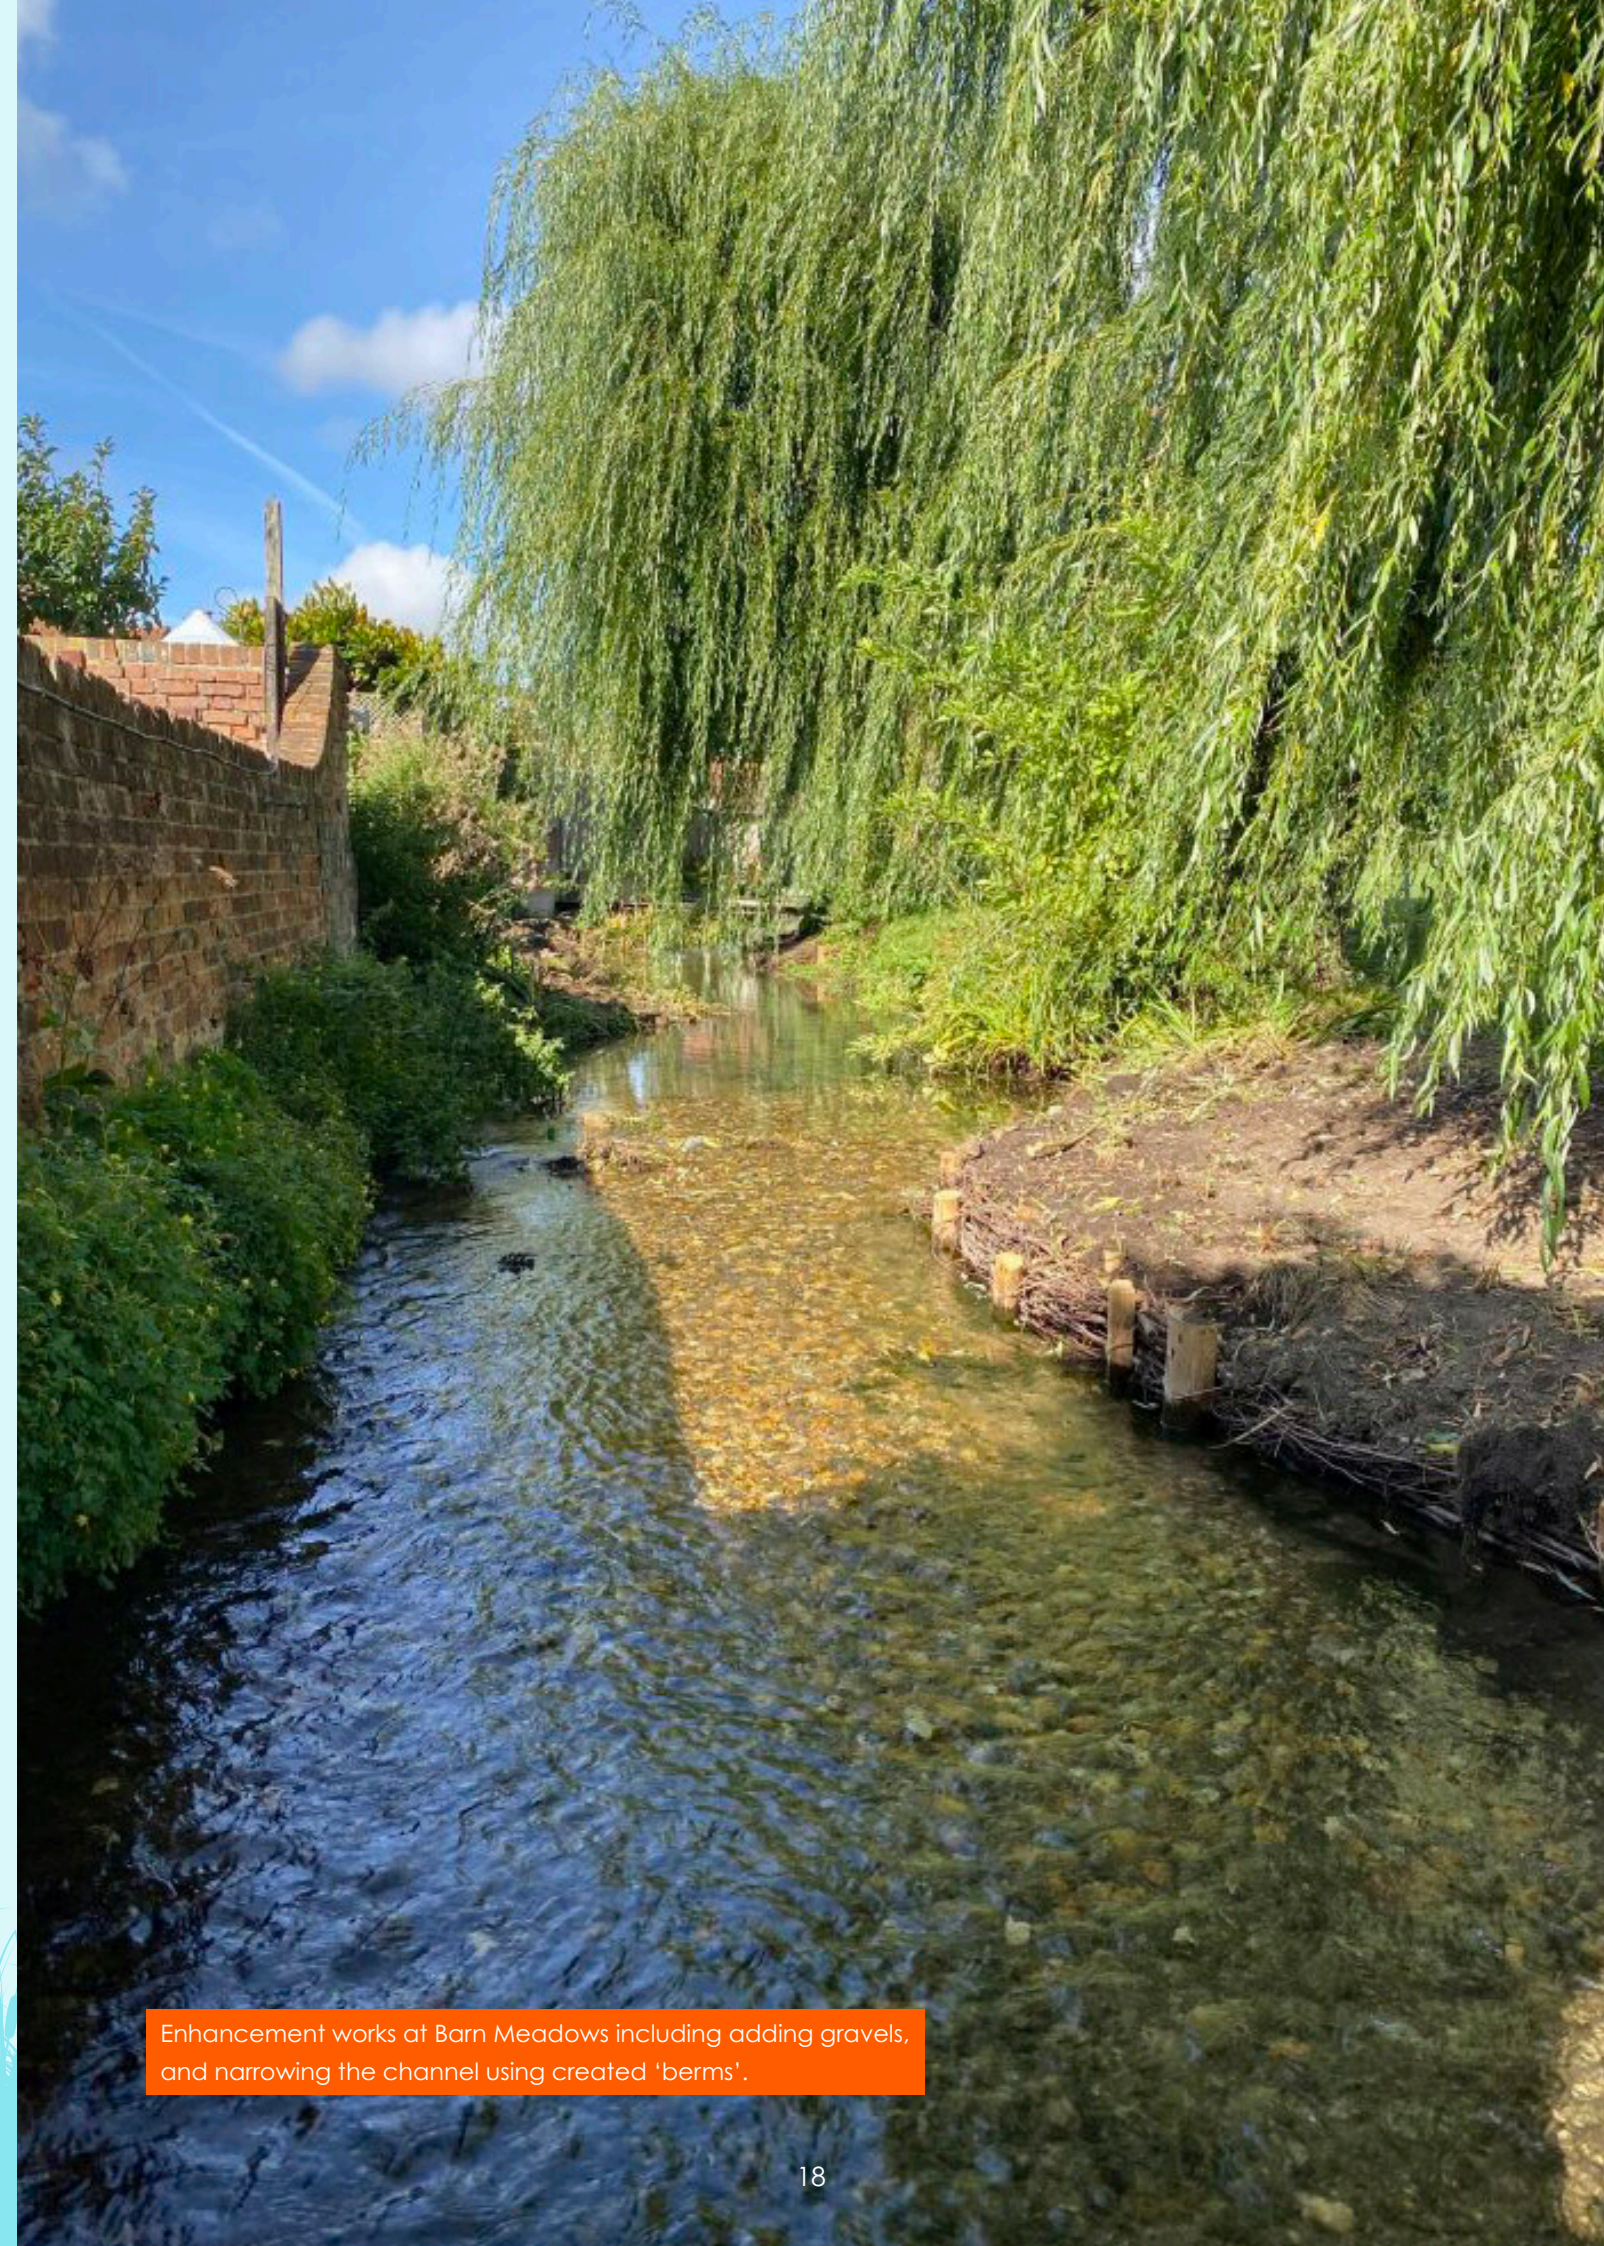
Enhancement works at Barn Meadows including adding gravels, and narrowing the channel using created 'berms'.

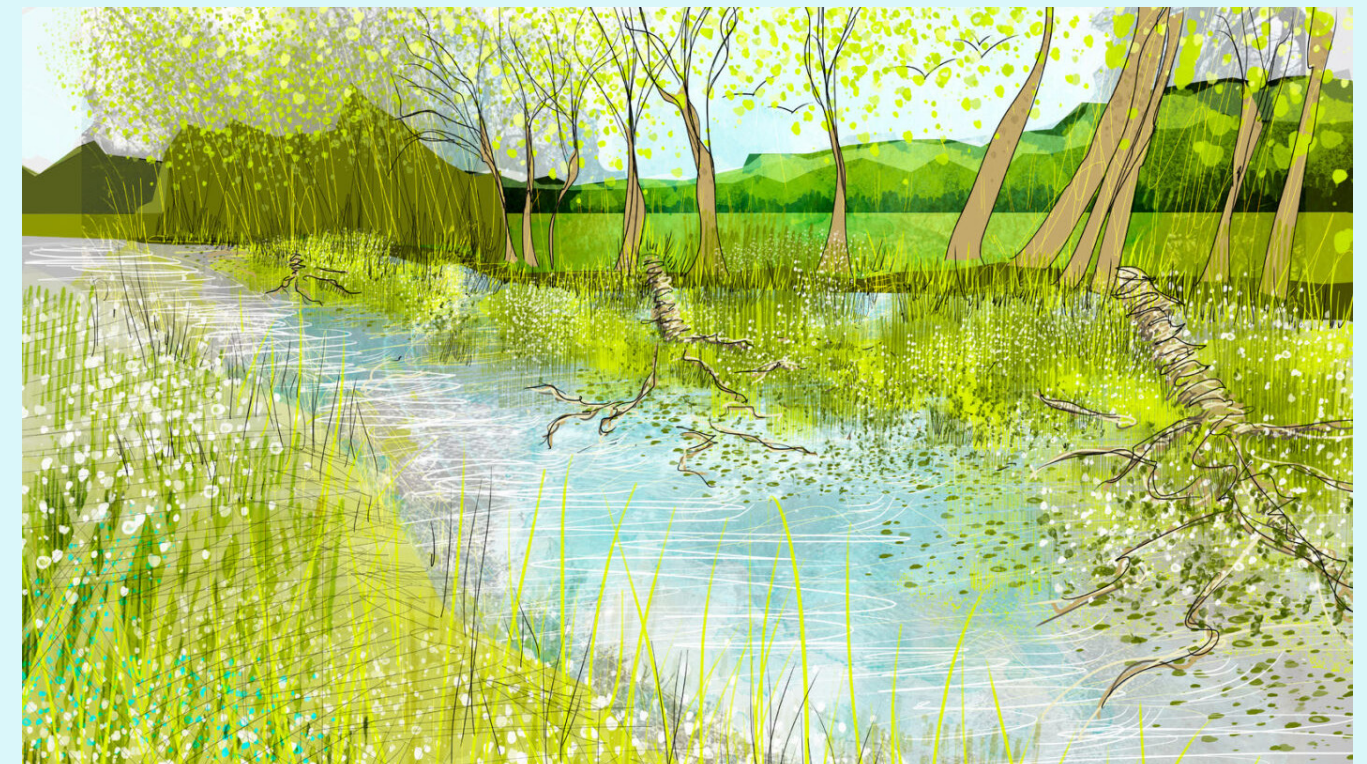
Tree hinging, providing a mosaic of shade and daylight.
